Contract #: 04-0120F4Cty: SF/ALA Rte: 80 PM: 13.2/13.9File #: 69.28**WELDING INSPECTION REPORT****Resident Engineer:**Siegenthaler, Peter**Address:** 333 Burma Road**City:** Oakland, CA 94607**Report No:** WIR-016754**Date Inspected:** 14-Sep-2010**Project Name:** SAS Superstructure**OSM Arrival Time:** 700**Prime Contractor:** American Bridge/Fluor Enterprises, a JV**OSM Departure Time:** 1900**Contractor:** Zhenhua Port Machinery Company, Ltd (ZPMC), Changxing Island **Location:** Shanghai, China**CWI Name:** Mr. Huang min**CWI Present:** Yes No**Inspected CWI report:** Yes No N/A**Rod Oven in Use:** Yes No N/A**Electrode to specification:** Yes No N/A**Weld Procedures Followed:** Yes No N/A**Qualified Welders:** Yes No N/A**Verified Joint Fit-up:** Yes No N/A**Approved Drawings:** Yes No N/A**Approved WPS:** Yes No N/A**Delayed / Cancelled:** Yes No N/A**Bridge No:** 34-0006**Component:** Orthotropic Box Girder(OBG)**Summary of Items Observed:**

This CALTRANS OSM Quality Assurance Inspector (QA) Surendra Prabhu was present during the times noted above for observations relative to the fabrication of the Self Anchored Suspension (SAS) Superstructure being performed by Zhenhua Por

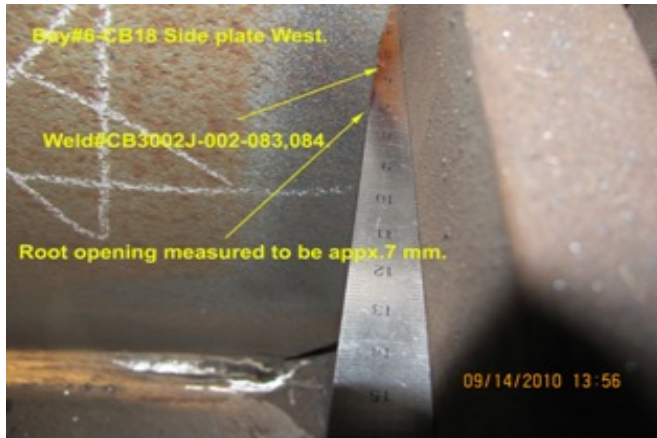
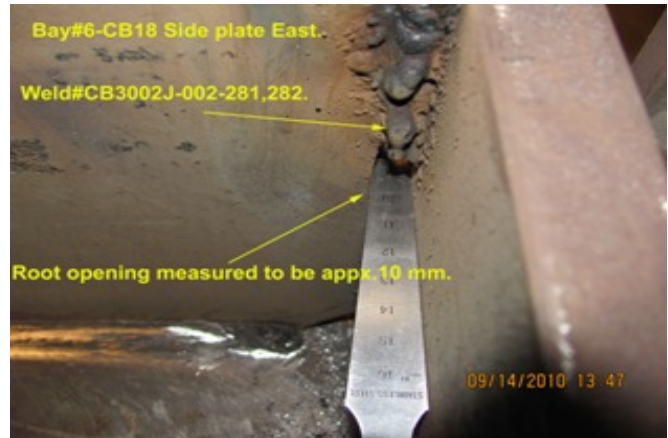
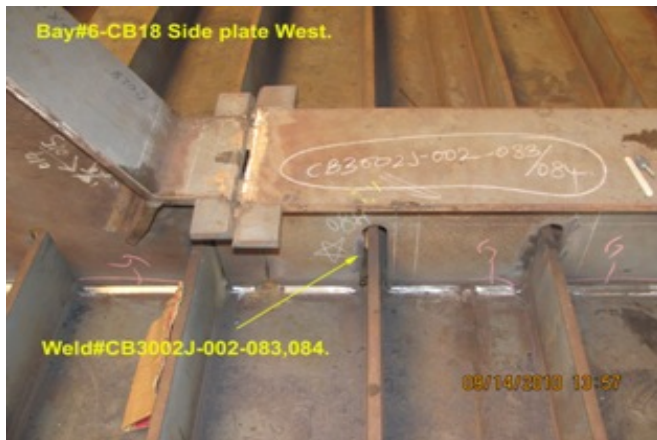
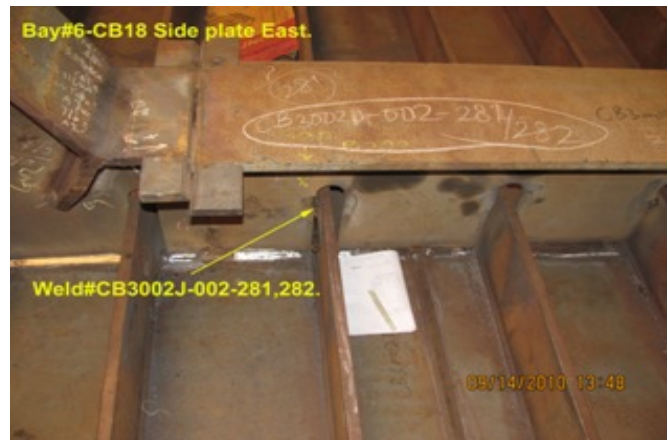
During Random in process visual inspection of Cross beam CB18 Side plates East and West, this QA Inspector observed that the excessive root openings between parts measured to be approximately 7 and 10 mm.

The effected weld joints are identified as CB3002J-002-083,084 and CB3002J-002-281,282 respectively. These root openings exceed the maximum tolerance specified in AWS D1.5 2002 section 3, paragraph 3.3.1. The approved drawing specifies fillet welds of these joints. This QA informed to ZPMC QC Certified Welding Inspector (CWI) identified as Mr.Huang min and American Bridge/Fluor (AB/F) QA Inspector Mr. Liu Hua Jie. Mr.Liu Fa Wen and Mr. Liu Hua Jie informed this QA that the root openings would be corrected in a manner compliant with the contract documents. Refer the attached photos for further information.
